Enniscrone Beach- Bathing Water Profile

Bathing Water: Enniscrone Beach

Bathing Water Code: IEWEBWC420_0000_0100

Local Authority: Sligo County Council

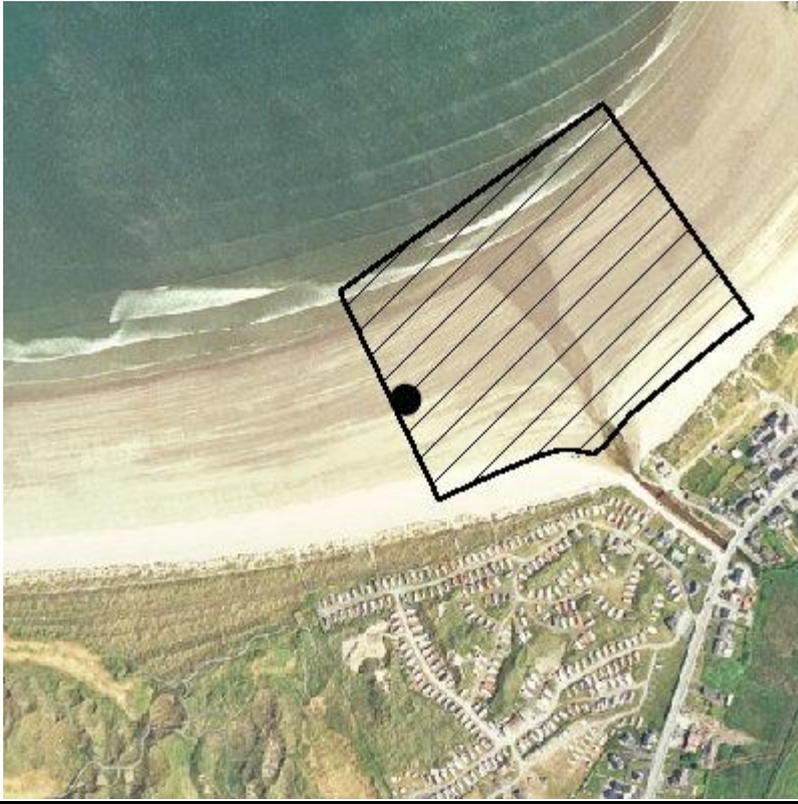
Bathing Water Location & Extent

Bathing Water location and extent:

Enniscrone beach is a popular sandy beach, located in west Sligo just 10 km from Ballina in Co. Mayo and 56km from Sligo town. The beach is located in Killala Bay east of the River Moy Estuary.

The beach extends westward from the promenade along the Cliff Road to the county boundary at the River Moy near Bartra Island. This is a fine sandy beach, approximately 4.5km in length, and is backed by sand dunes, a golf course and caravan park. The bathing area (i.e. that which is patrolled by lifeguards) is approximately 500m in length.

The Bellawaddy stream flows onto Enniscrone Beach with the bathing area located to the east and west of the stream. The east beach lies close to the promenade and is backed by an area known locally as the hollow. The west part of the beach is backed by a caravan park and golf course. The west beach extends westward from the Bellawaddy stream to the county boundary at the River Moy near Bartra Island.
