Bathing Water Profile

Ballywalter

May 2018

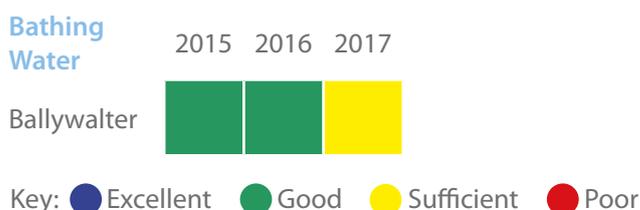
Ballywalter Bathing Water Quality 2015-2017

In 2015 the 1976 Bathing Water Directive was replaced by the European Bathing Water Directive 2006/7/EC. This revised directive introduced more stringent bathing water standards. Bathing Waters are classified as Excellent, Good, Sufficient or Poor (see above). This classification is based on a statistical assessment of results from the last four years.

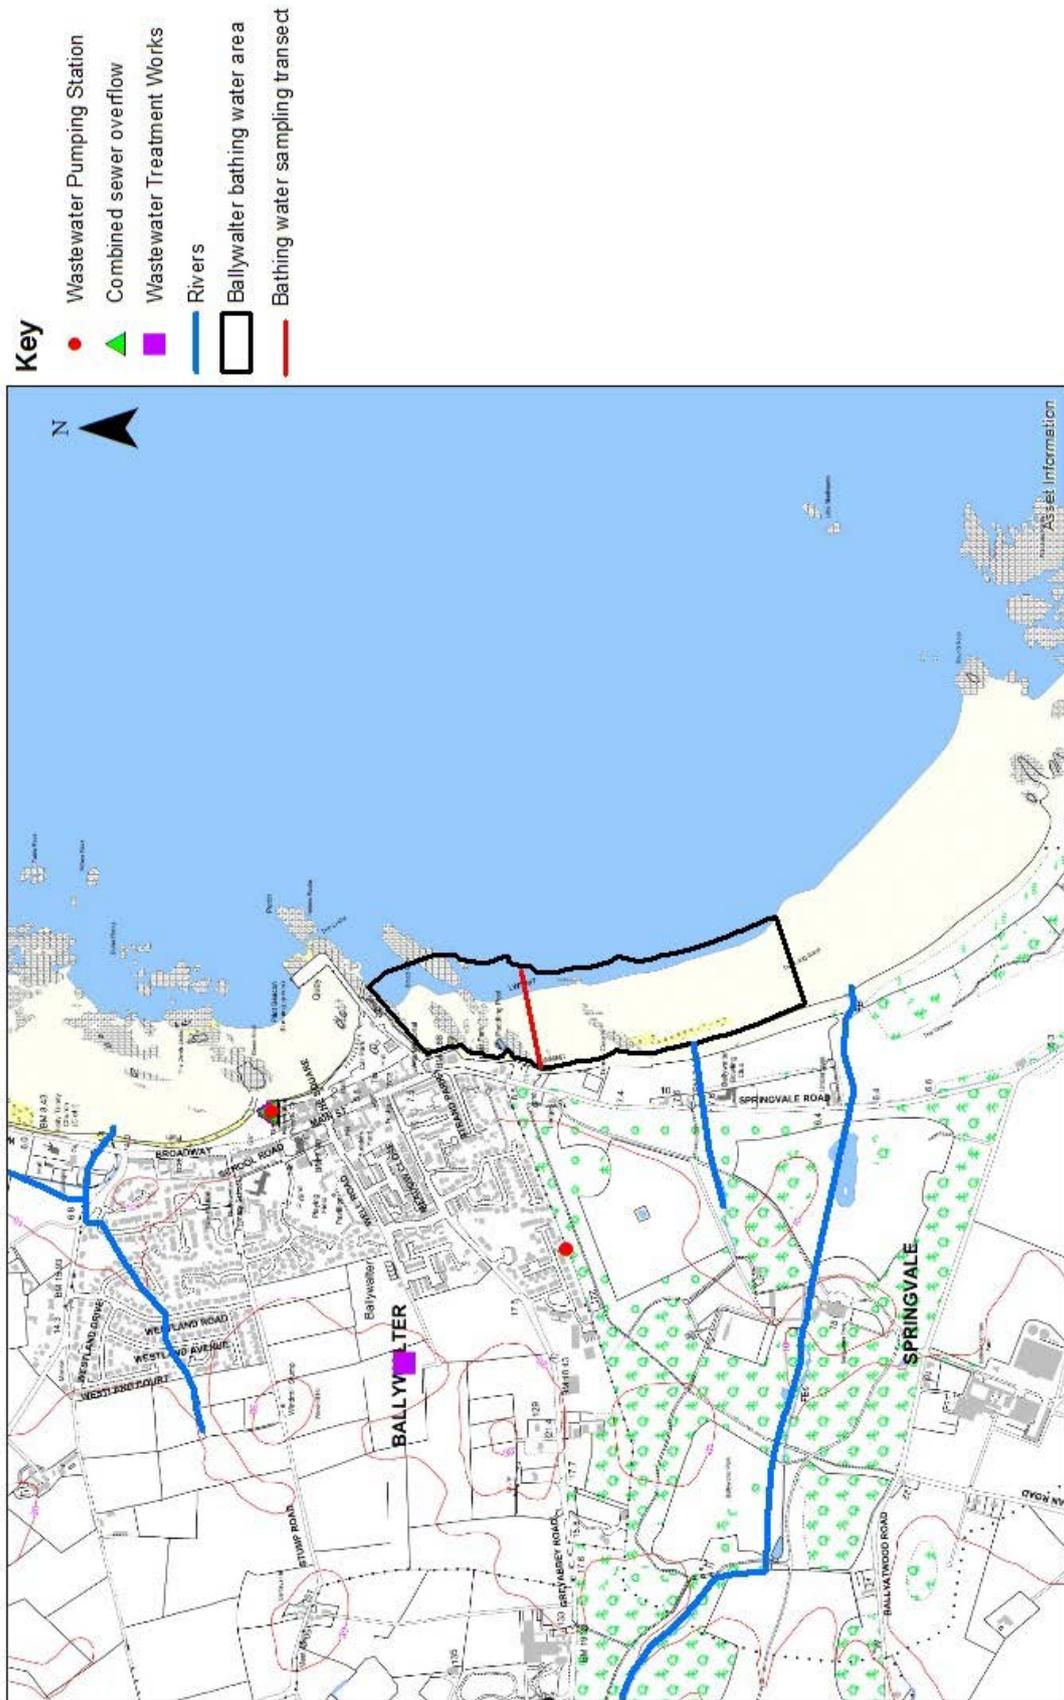
Map 1
Ballywalter Bathing Water -
Potential Pollution Sources

The municipal collection and treatment of waste water has the potential to cause pollution because all combined collection systems must be designed to overflow in periods of extreme wet weather or following failure of the system. If systems are not designed in that way, then sewers may overflow into residential areas. Within Ballywalter bathing area there are several wastewater pumping stations with associated emergency overflows as shown on Map 1.

There is one waste water treatment works inland from the village. Effluent from the secondary treatment process is discharged to sea north of the harbour, some 700m from the bathing water.

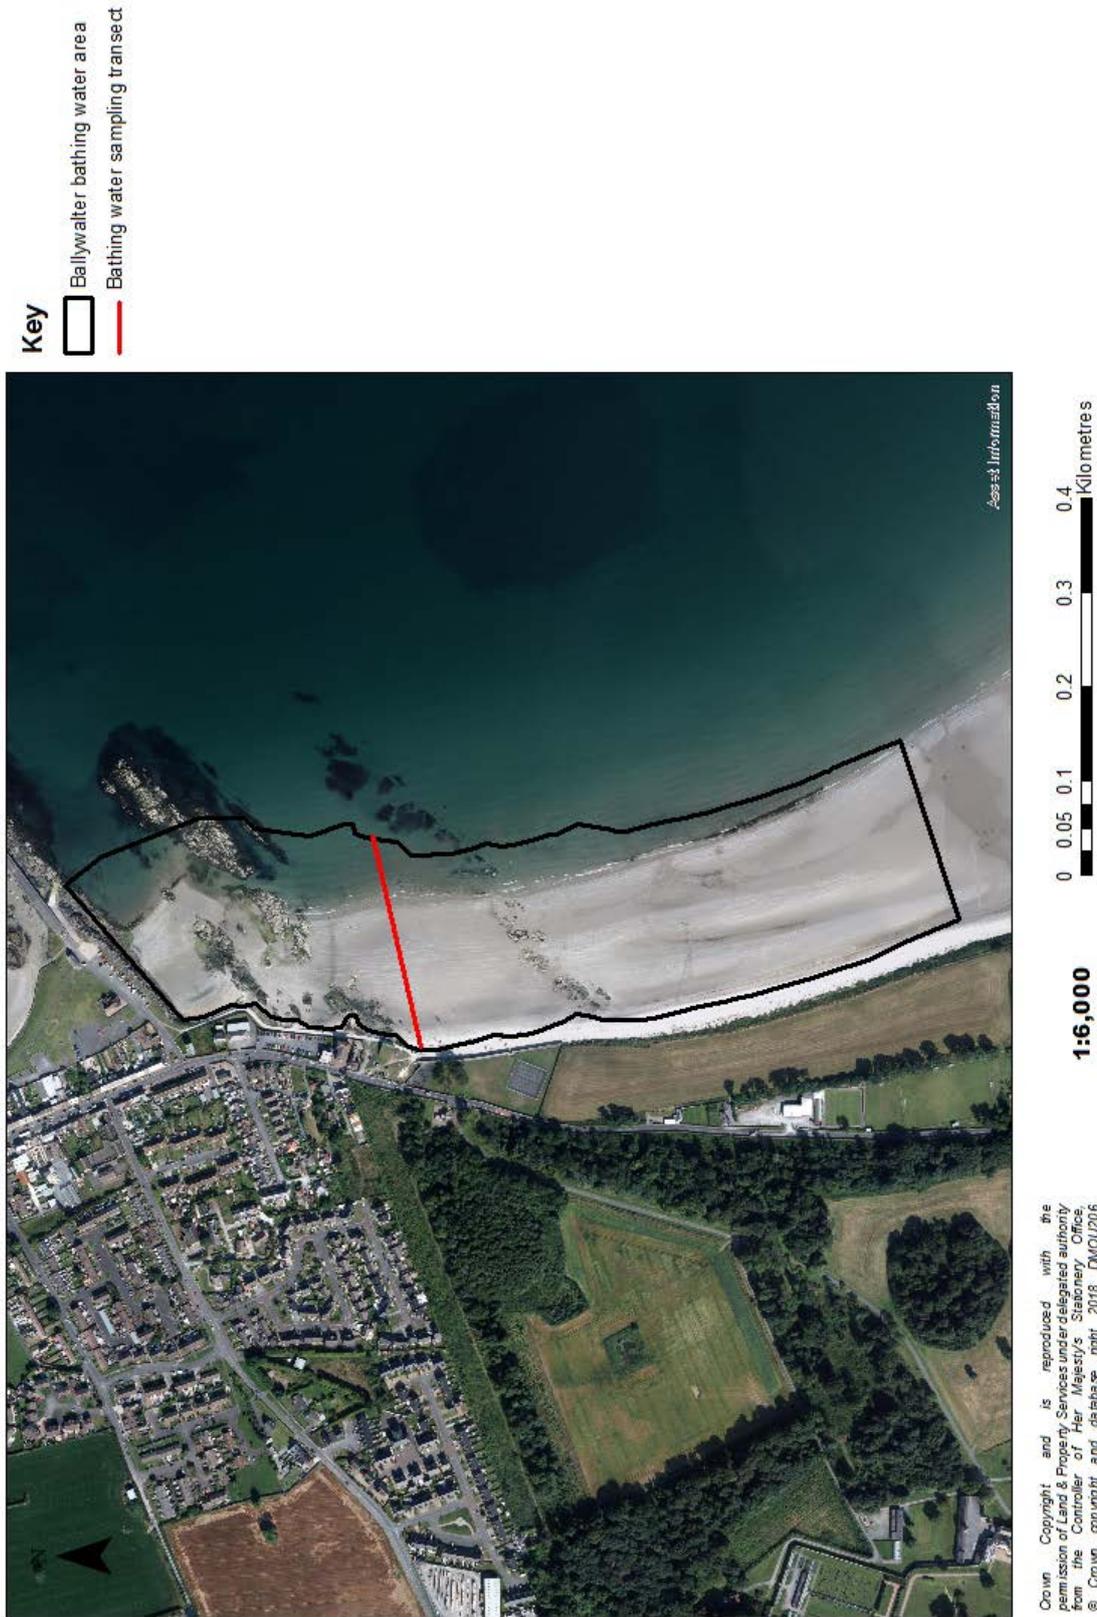
Map 2
Ballywalter Bathing Water -
EC Bathing Water Sample Location

Bathing Water Name	Ballywalter Bathing Water
EU bathing water ID number	UKNO3_53500
Location	UK/Northern Ireland/County Down/North Down Coast
Year of identification	2006
Local council area	Ards and North Down Borough Council
Bathing Water Operator	Ards and North Down Borough Council
Description of bathing beach	Sand, approximately 0.85 kilometres in length.
Monitoring Point	Northern end of bathing water, J62956864 (Map 2)
