Bathing Water Profile

Waterfoot

May 2018

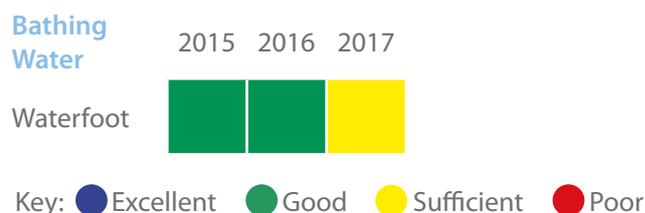
Waterfoot Bathing Water Quality 2015-2017

In 2015 the 1976 Bathing Water Directive was replaced by the European Bathing Water Directive 2006/7/EC. This revised directive introduced more stringent bathing water standards. Bathing Waters are classified as Excellent, Good, Sufficient or Poor (see above). This classification is based on a statistical assessment of results from the past four years.

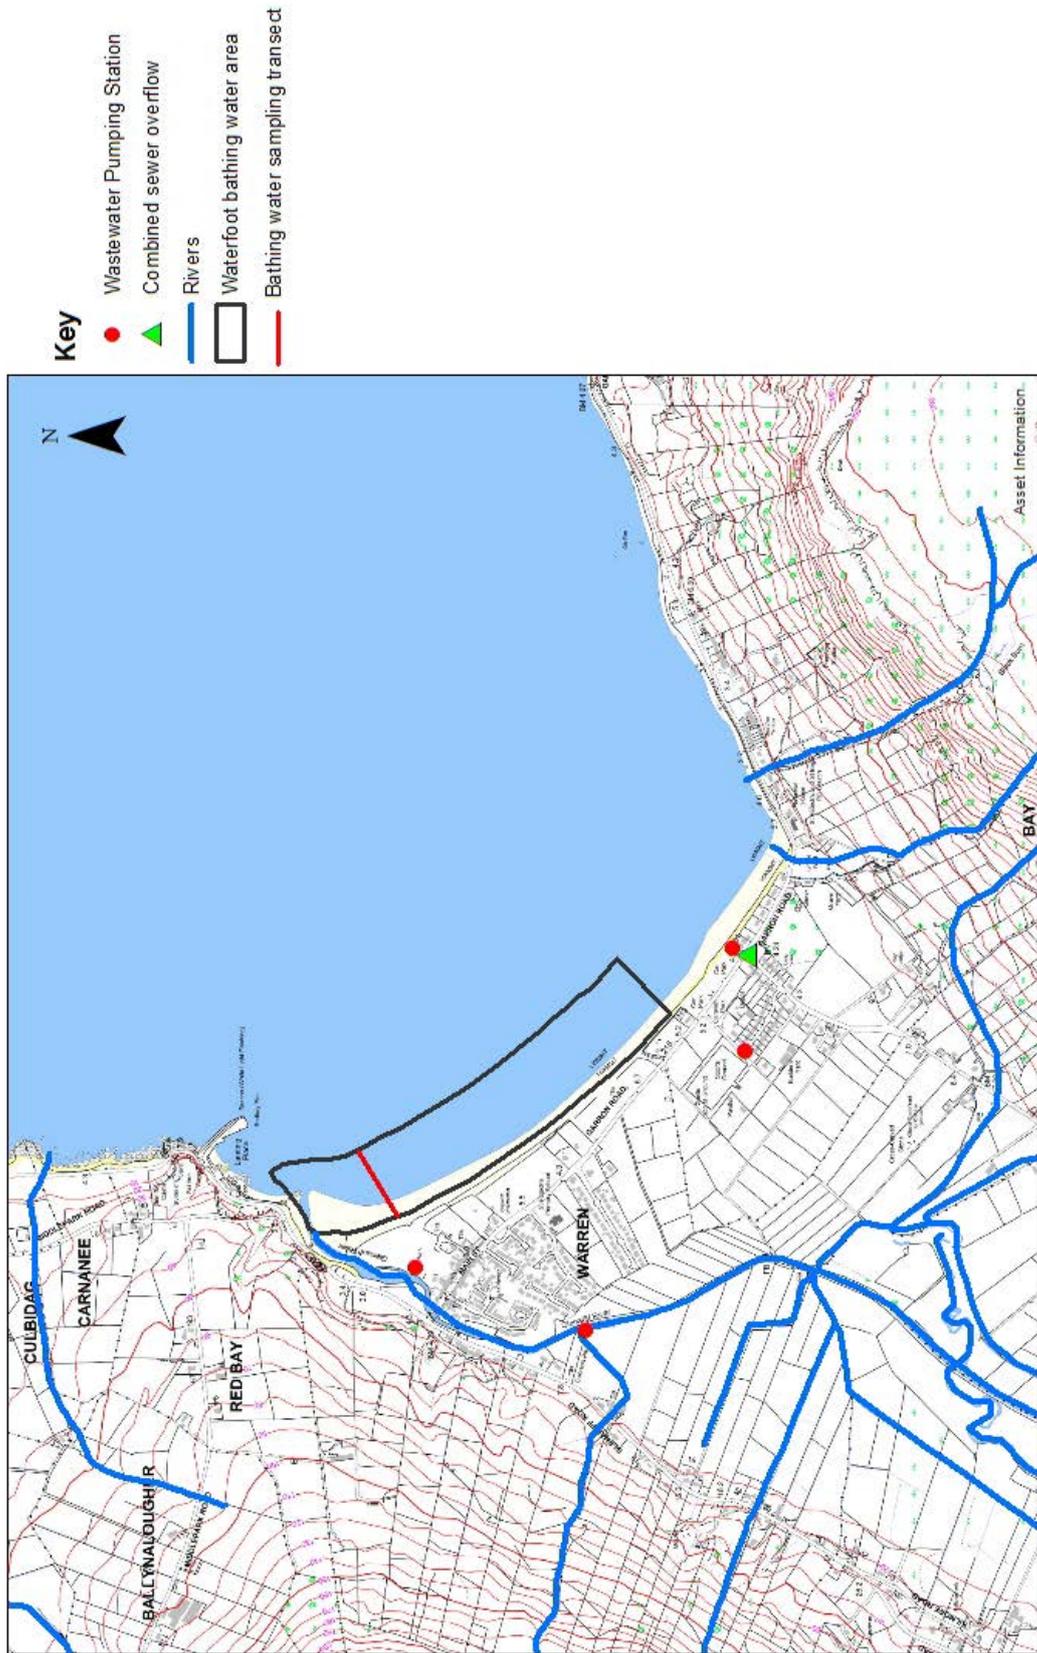
Map 1
Waterfoot Bathing Water -
Potential Pollution Sources

(CSO), emergency overflows and wastewater pumping stations with associated emergency overflows as shown on Map 1.

The municipal collection and treatment of waste water has the potential to cause pollution because all combined collection systems must be designed to overflow in periods of extreme wet weather or following failure of the system. If systems are not designed in that way, then sewers may overflow into residential areas. Within the wider Waterfoot and Cushendall area there are combined sewer overflows

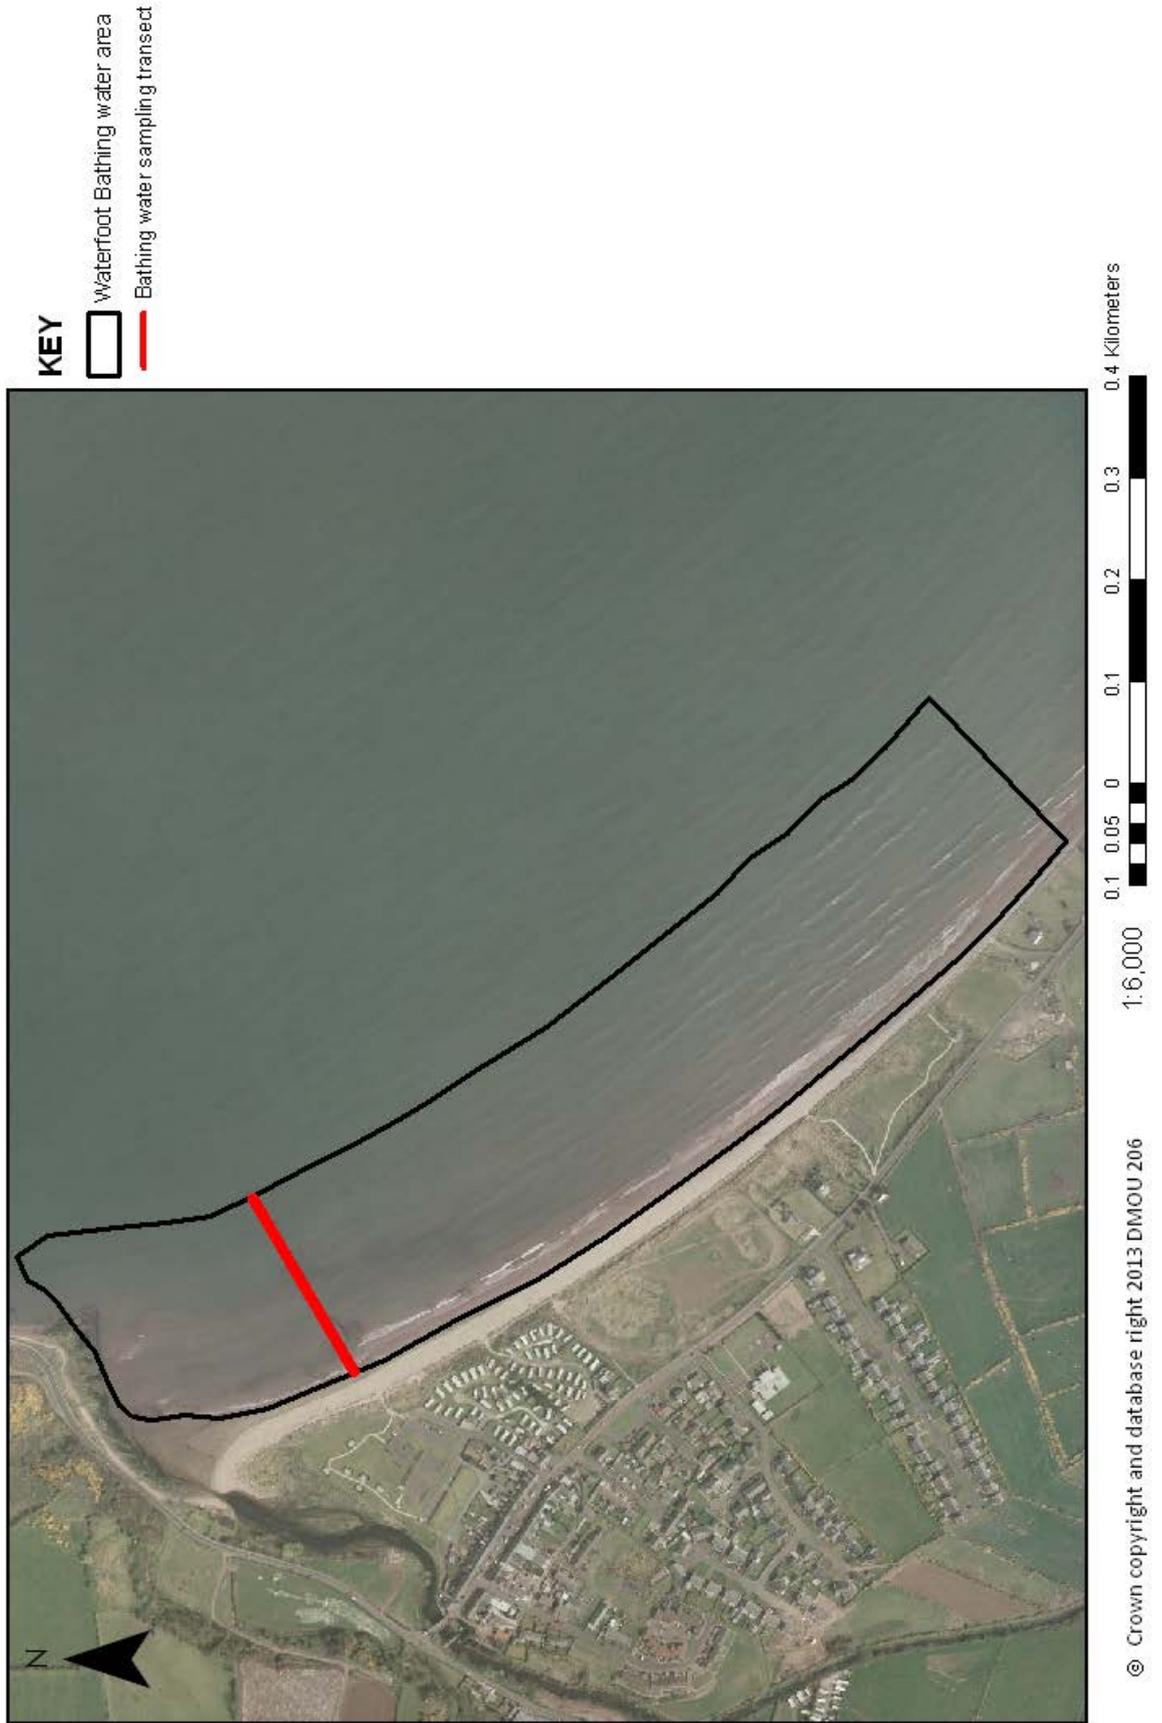
Map 2
Waterfoot Bathing Water -
EC Bathing Water Sample Location

Bathing Water Name	Waterfoot Bathing Water
EU bathing water ID number	UKNO4_50700
Location	UK/Northern Ireland/County Antrim/Antrim Coast
Year of identification	2006
Local council area	Causeway Coast and Glens Borough Council
Bathing Water Operator	Causeway Coast and Glens Borough Council
Description of bathing beach	Sand, approximately 1.0 km in length, bounded by a river to the north
Monitoring Point	Northern end of bathing water, D 24192560 (Map 2)
